PIC16C62A Rev. A Silicon Errata Sheet

The PIC16C62A (Rev. A) parts you have received conform functionally to the Device Data Sheet (DS30234D), except for the anomalies described below.

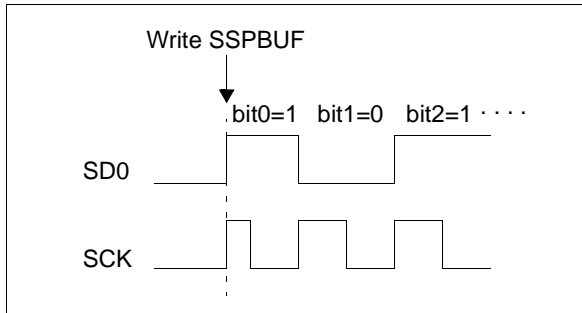
FIGURE 1: SCK PULSE VARIATION USING TIMER2/2

4. Module: SSP (SPI Mode)

When the SPI is using Timer2/2 as the clock source, a shorter than expected SCK pulse may occur on the first bit of the transmitted/received data (Figure 1).

Work around

To avoid producing the short pulse, turn off Timer2 and clear the TMR2 register, load the SSPBUF with the data to transmit, and then turn Timer2 back on. Refer to Example 1 for sample code.

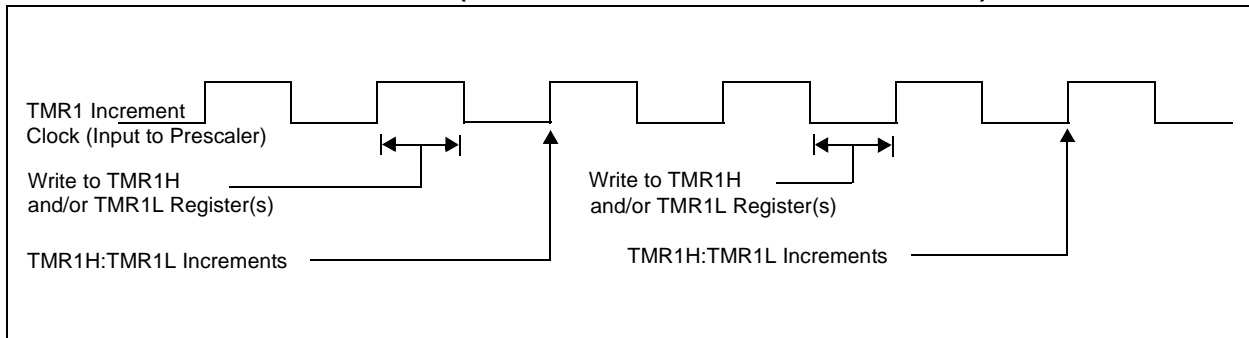
FIGURE 1: WRITES TO TIMER1 (EXTERNAL CLOCK/OSCILLATOR MODE)

The operation of Timer1 needs some clarification when the timer registers are written and the TMR1ON bit is set.

The internal clock signal, that is the input to the TMR1 prescaler, affects the incrementing of Timer1 (TMR1H:TMR1L registers and the Timer1 prescaler). When the Timer1 registers are NOT written, the Timer1 will increment on the rising edge of the TMR1 increment clock.

When the TMR1H and/or TMR1L registers are written while this clock is high, TMR1 will increment on the next rising edge of this clock.

When the TMR1H and/or TMR1L registers are written while this clock is low, TMR1 will not increment on the next rising edge of this clock, but must first have a falling clock and the rising clock for TMR1 to increment.

Figure 1 shows the two cases of writes to the TMR1H and/or TMR1L registers. Due to the V_{IH} and V_{IL} thresholds on the oscillator/clock pins, external Timer1 oscillator components, and external clock frequency, the Timer1 increment clock may not be of a 50% duty cycle.

The TMR1 increment clock is out of phase of the T1OSO/T1CKI pin by a small propagation delay.
